# Semi-annual Environmental Monitoring Report

## **#18 Semiannual Report**

*(Reporting Period: July-December 2024)*

**GEORGIA: URBAN SERVICES IMPROVEMENT INVESTMENT PROGRAM  
(TRANCHE 4)  
(FINANCED BY THE ASIAN DEVELOPMENT BANK)**

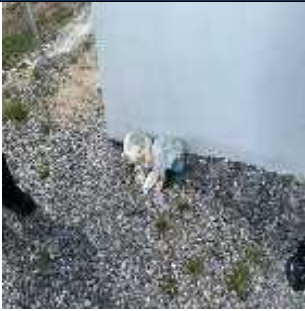
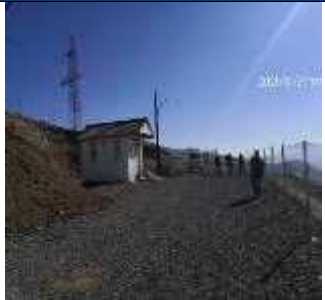
Photo N1

2	<p><b>Non-compliance 2:</b> Oil Spill was identified on the project area of the Gudauri Reservoir</p>	<p>Fuels and lubricants spills should be eliminated. The territory should be cleaned and reinstated and oil contamination should be removed until the end of December 2024 Photo N1</p>

UWSCG	<p>Improved, December 2024, Photo N1</p>

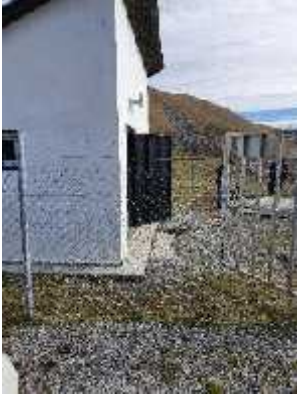
3	<p><b>Non-compliance 3:</b> The area around the well fields inside the fence was contaminated with animal fecal matter</p>	<p>The area of the well fields must be cleaned promptly, the gate should be closed to prevent accidental entry of people and animals into the well field area until the end of December 2024, Photo N1</p>

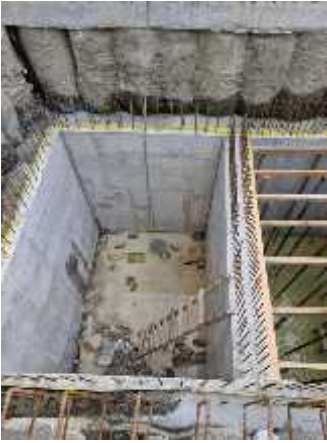
Date of Visit	Name of Company	Auditors Name	Purpose of audit	Summary of any Significant Findings	Cross Reference to Audit Report	Status of implementation
Continuously during reporting period (July-December 2024)	<b>POT-01/LOT-01/LOT-02/LOT-03</b>	Environmental Specialist of SC Mr.Shalva Bosikashvili	Day to day monitoring of sites  Compliance with Environmental and HES requirements	Poor housekeeping Safety issues on construction sites	Monthly Monitoring Reports	Completed on the monthly basis
22 July 2024	Contractor: CHINA NUCLEAR INDUSTRY 23 CONSTRUCTION CO” Ltd (China)  POT-01/LOT-03	Environmental Specialist of SC Mr.Shalva Bosikashvili	Monthly Monitoring of Sites	Handmade unsafe ladder, Photo N1

Concrete spills, on the construction area, Photo N2	Non-compliance notice were issued to contractor and corrective actions were required from contractor to immediately improve the situation, under POT-01/LOT-03 sub-project (Please see Annex C)	Completed, end of July 2024  Completed, end of July 2024, concrete is removed and territory is reinstated, Photo N1

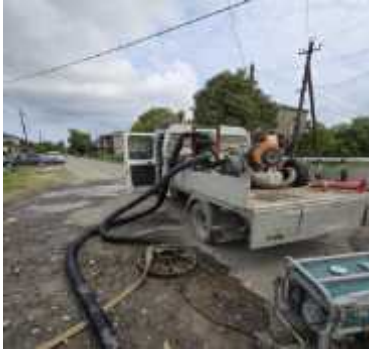
23 July 2024	<p>Contractor: “MBD Inssat” (Turkey).</p> <p>POT-01/LOT-02</p>	<p>Environmental Specialist of SC Mr. Shalva Bosikashvili</p> <p>Ms. Kate Chomakhidze UWSCG/USIIP/Environmental Specialist</p>	Monthly Monitoring of Sites	<p>LOT-02</p> <p>Power generator without drip tray, Photo N1</p>

<p>Non-compliance notice were issued to contractor and corrective actions were required from contractor to immediately improve the situation, under POT-01/LOT-02 sub-project (Please see Annex C)</p>	Completed. July 2024
24 July 2024	Contractor: “MBD Inssat” (Turkey).	Environmental Specialist of SC Mr. Shalva	Regular Monitoring of	Deep pit without barrier and warning sign, unauthorized persons at the construction	Non-compliance notice were	Completed, end of July 2024,

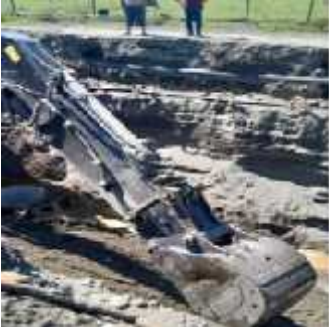
Date of Visit	Name of Company	Auditors Name	Purpose of audit	Summary of any Significant Findings	Cross Reference to Audit Report	Status of implementation
	POT-01/LOT-02	Bosikashvili	sites	<p>site, Photo N1</p>

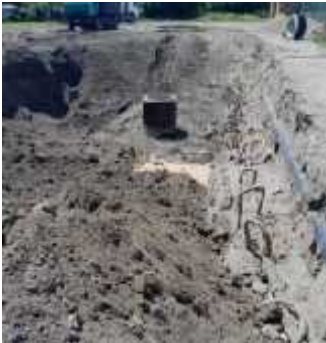
<p>Deep pit without barrier, Photo N2</p>

issued to contractor and corrective actions were required from contractor to immediately improve the situation, under POT-01/LOT-02 sub-project (Please see Annex C)	<p>Photo N1</p>

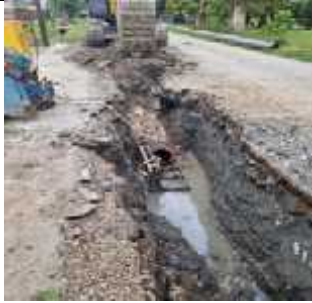
14 August 2024	Contractor: "ECETAS"  POT-01/LOT-01	Environmental Specialist of SC Mr. Shalva Bosikashvili	Regular Monitoring of sites	Open trench without barrier/warning tape, warning sign, Photo N1	Non-compliance notice were issued to contractor and corrective actions were required	Completed, Mid. August 2024, Photo N1

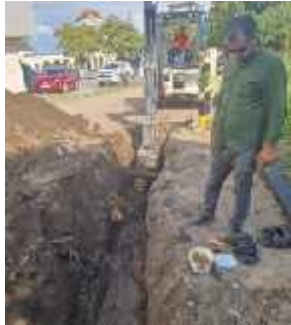
<p>Worker without helmet in the trench, Photo N2</p>

<p>Person without PPE at the construction site</p>	<p>from contractor to immediately improve the situation, under POT-01/LOT-02 sub-project (Please see Annex C)</p>

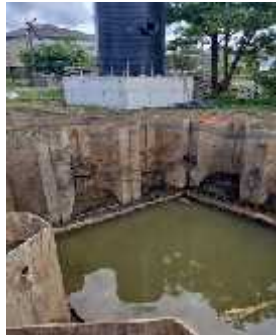
<p>Worker without helmet in the trench</p>	<p>from contractor to immediately improve the situation, under POT-01/LOT-01 sub-project (Please see Annex C)</p>	<p>Completed Mid. August 2024</p>
<p>16 August 2024</p>	<p>Contractor: CHINA NUCLEAR INDUSTRY 23 CONSTRUCTION CO” Ltd (China) POT-01/LOT-03</p>	<p>Environmental Specialist of SC Mr. Shalva Bosikashvili</p>	<p>Regular Monitoring of sites</p>	<p><b>LOT3</b></p> <p>Deep pit without barrier and warning sign, Photo N1</p>

<p>Rebar without capping, Photo N2</p>	<p>Non-compliance notice were issued to contractor and corrective actions were required from contractor to immediately improve the situation, under POT-01/LOT-03 sub-project (Please see Annex C)</p>	<p>Completed end of August 2024</p>

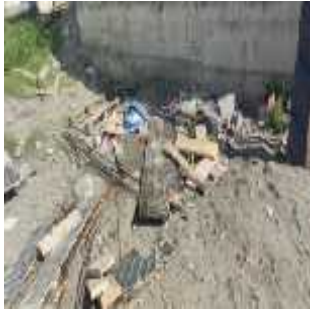
18 September 2024	Contractor: CHINA NUCLEAR INDUSTRY 23 CONSTRUCTION CO” Ltd (China) POT-01/LOT-03	Environmental Specialist of SC Mr. Shalva Bosikashvili	Regular Monitoring of Sites	<p>Unacceptable housekeeping, Photo N1</p>

<p>Generator without drip tray</p>	<p>Non-compliance notice were issued to contractor and corrective actions were required from contractor to immediately improve the situation, under POT-01/LOT-03 sub-project (Please see Annex C)</p>	<p>Completed, end of September 2024, Photo N1</p>

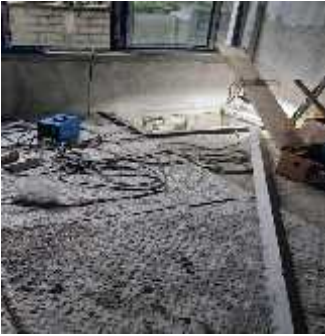
Date of Visit	Name of Company	Auditors Name	Purpose of audit	Summary of any Significant Findings	Cross Reference to Audit Report	Status of implementation
22 October 2024	Contractor: CHINA NUCLEAR INDUSTRY 23 CONSTRUCTION CO” Ltd (China) POT-01/LOT-03	Environmental Specialist of SC Mr.Shalva Bosikashvili	Regular Monitoring of sites	<p>Unsafe wiring on construction site, Photo N1</p>

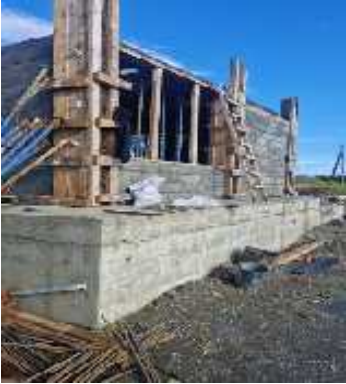
<p>Unsafe ladder on construction site, Photo N2</p>

<p>Completed, unsafe ladder was removed from the construction site, immediately</p> <p>Completed,</p>

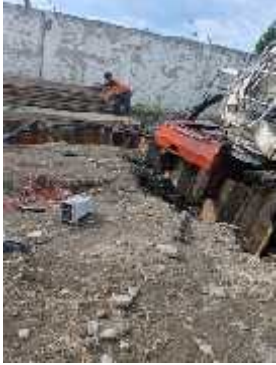
<p data-bbox="1125 602 1470 667">Worker without PPE in the trench</p>		<p data-bbox="1759 207 1923 240">immediately</p> <p data-bbox="1759 570 1923 634">Completed, immediately</p>
18 November 2024	<p data-bbox="382 704 562 802">Contractor: “MBD Inssat” (Turkey).</p> <p data-bbox="382 829 495 922">POT-01/LOT-02</p>	<p data-bbox="606 704 821 829">Environmental Specialist of SC Mr. Shalva Bosikashvili</p> <p data-bbox="606 862 850 1024">Ms. Kate Chomakhidze UWSCG/USIIP/Environmental Specialist</p>	Regular Monitoring of Sites	<p data-bbox="1125 704 1451 797">Deep trenches without barrier and warning sign, Photo N1</p>

<p data-bbox="1507 704 1667 1370">Non-compliance notice were issued to contractor and corrective actions were required from contractor to immediately improve the situation, under POT-01/LOT-02 sub-project (Please see Annex C)</p>	<p data-bbox="1759 704 1982 802">Completed, November 2024, Photo N1</p>

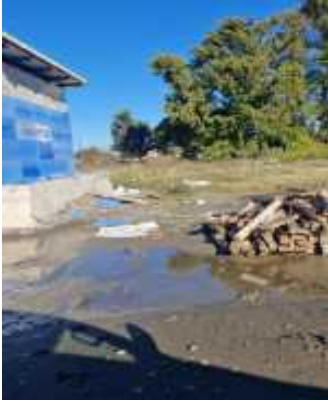
Date of Visit	Name of Company	Auditors Name	Purpose of audit	Summary of any Significant Findings	Cross Reference to Audit Report	Status of implementation
19 November 2024	Contractor: CHINA NUCLEAR INDUSTRY 23 CONSTRUCTION CO” Ltd (China) POT-01/LOT-03	Environmental Specialist of SC Mr. Shalva Bosikashvili	Regular Monitoring of sites	<p>Unacceptable housekeeping, Photo N1</p>

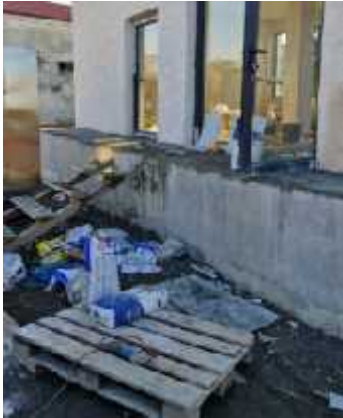
<p>Unacceptable housekeeping and unsafe ladder, Photo N2</p>

<p>Non-compliance notice were issued to contractor and corrective actions were required from contractor to immediately improve the situation, under POT-01/LOT-02 sub-project (Please see Annex C)</p>	<p>Completed, end of November 2024</p> <p>Completed, end of November 2024, Photo N1</p>

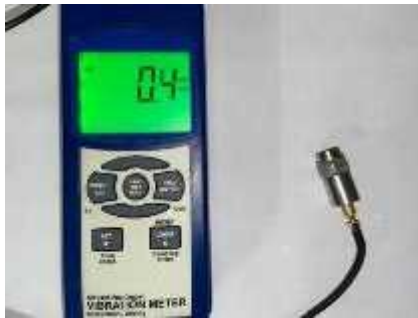
**Figure 3: REED instruments SD-8205 model adapter**

96. Vibration level is determined by the REED instruments SD-8205 model adapter.
97. Vibration analysis is a process that monitors vibration levels and investigates the patterns in vibration signals. It is commonly conducted both on the time waveforms of the vibration signal directly, as well as on the frequency spectrum, which is

obtained by applying Fourier Transform on the time waveform.

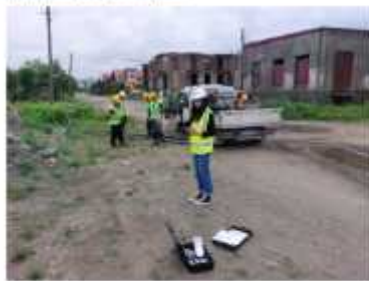
Figure 3.1 Noise (DMM) Monitoring Point

During the monitoring process, all devices were included and the work process was running as full scale.

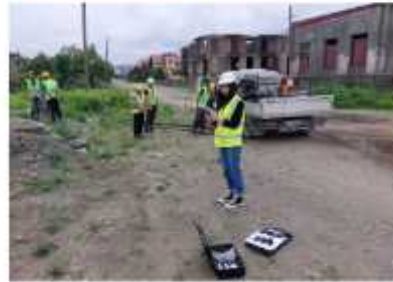
Figure 1.1 Air Quality Monitoring point (AIA #1)

During the monitoring process, all devices were included and the work process was running as full scale.

Table 2.1.1 AIA#1-41 Dust Particles (ppm), Carbon Monoxide (CO), Nitrogen Oxides (NOx) and Sulphur Dioxide (SO<sub>2</sub>) monitoring results (PPM)

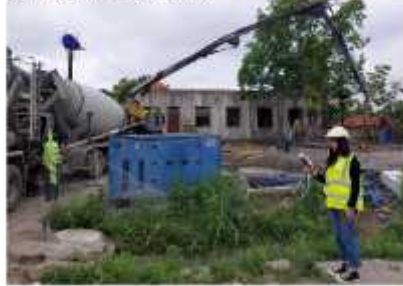
Figure 3.1 Air Quality Monitoring prior AAAS #1

During the monitoring process, all activities were included and the work process was running as per usual.

Table 3.1.1 AAAS#1 Short Particles (µg/m<sup>3</sup>), Carbon Monoxide (CO), Nitrogen Dioxide (NO<sub>2</sub>) and Sulphur Dioxide (SO<sub>2</sub>) monitoring results (PM)

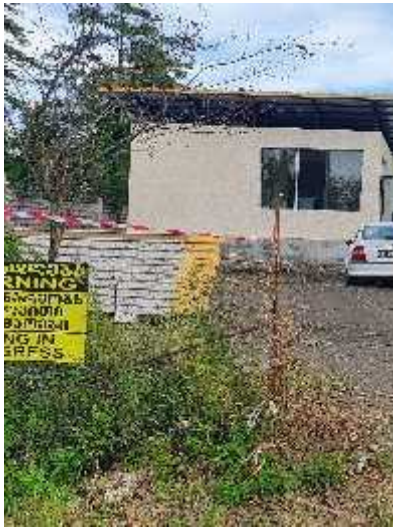
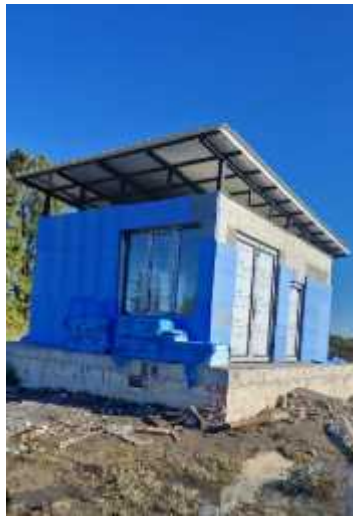
**PS 20 LOT-03**

**Construction of Pumping Stations**

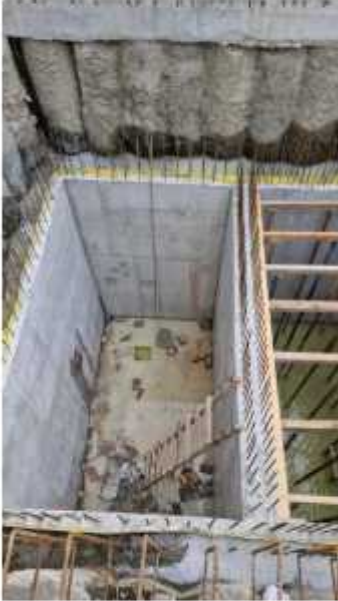
<b><u>NON-COMPLIANCE IN POTI 01</u></b>	
<b>WWTP Poti 01 LOT3</b>	
<ul style="list-style-type: none"><li>• Handmade unsafe ladder</li><li>• Concrete spills</li></ul>	
<b><i>Handmade unsafe ladder</i></b>

All these conditions have to be remedied within 10 days by the prime Contractor **CNI23**

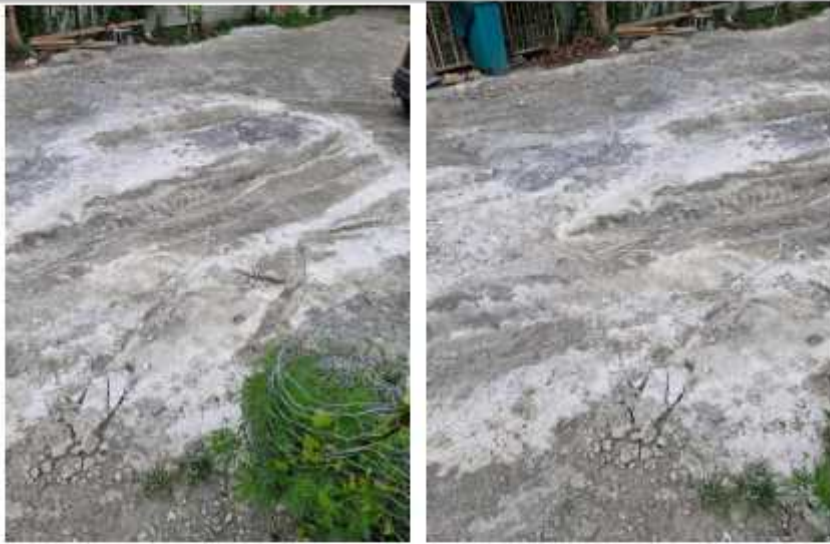
<b><i>Concrete spills</i></b>

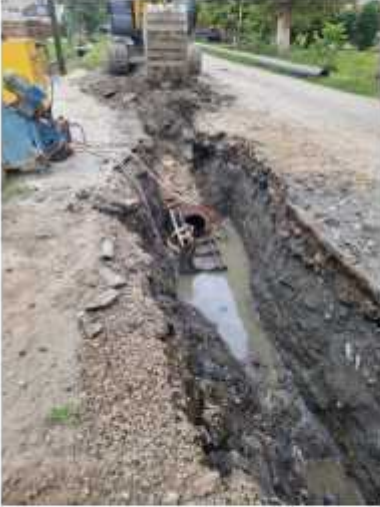
<b><u>NON-COMPLIANCE IN POTI 01</u></b>	
<b>WWTP Poti 01 LOT1</b>	
<ul style="list-style-type: none"><li>• Open trench without barrier/warning tape, warning sign</li><li>• Worker without helmet in the trench</li><li>• Worker without helmet and person without PPE at the construction site</li></ul>	
<b><i>Open trench without barrier/warning tape, warning sign</i></b>

All these conditions have to be remedied within 10 days by the prime Contractor **ECETAS**

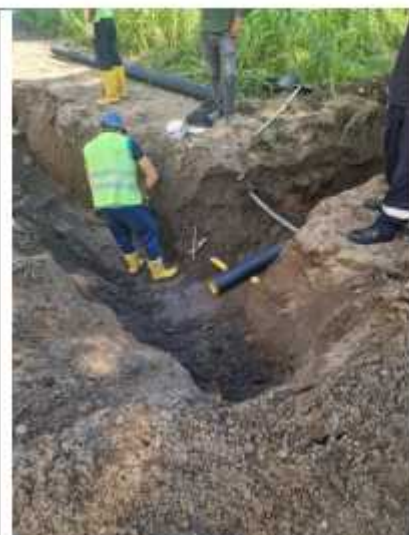
<b><i>Worker without helmet in the trench</i></b>

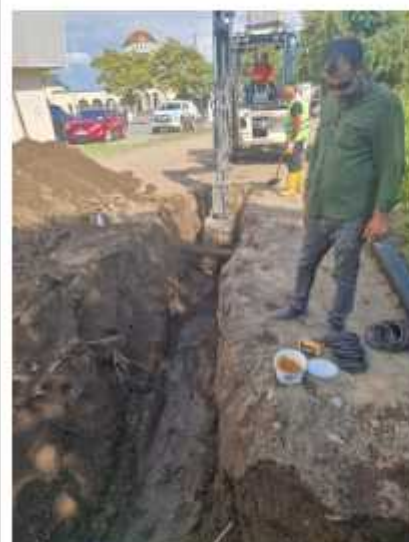
**Worker without helmet and person without PPE at the construction site**

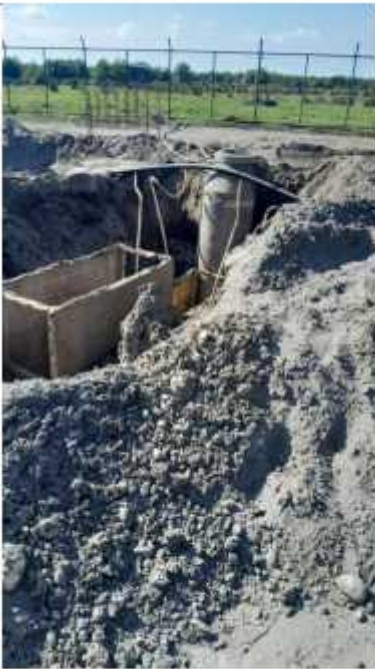
<b>NON-COMPLIANCE IN POTI 01</b>	
<b>WWTP Poti 01 LOT2</b>	
<ul style="list-style-type: none"><li>• Deep pit without barrier and warning sign</li><li>• Worker without helmet in the trench</li></ul>	
<b><i>Deep pit without barrier and warning sign</i></b>

All these conditions have to be remedied within 10 days by the prime Contractor **MBD**

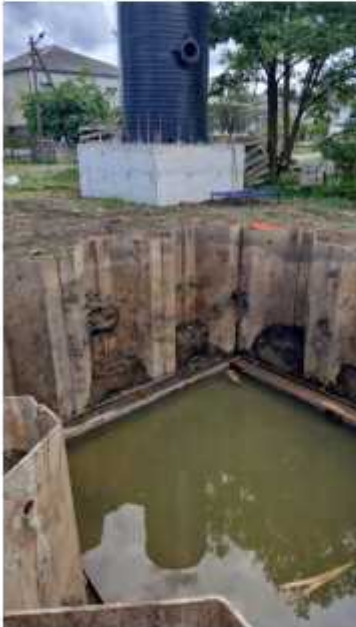
<b>Project:</b> Construction Supervision (under USIIP, Tranche 4 Projects), <b>UWSCG/USIIP/QCBS/02-2014</b>	<b>Non-compliance Notice Poti 01</b>
<b>Contract No:</b> P43405-ICB-POT-01	
<b>Contractor:</b> CNI23	
<b>Reference:</b>	
<p>This notice is to advise the prime Contractor, on the referenced Contract, of the following notice on health, safety and environmental measures to be implemented <b>urgently</b>.</p> <p><b><u>GENERAL COMMENT FOR ALL SITES:</u></b> Site internally should be arranged properly and cleaned regularly. All construction materials and wastes should be properly segregated and stored adequately, Oil spill response kits should be placed at the appropriate locations. Refuelling station should be equipped with the spill kit and fire relevant fighting equipment; drip tray should be used for fuel spillage prevention. Relevant traffic signs and flagmen should control traffic movement properly. PPE wearing is obligatory at the construction site.</p> <p><b><u>NON-COMPLIANCE IN POTI 01</u></b></p> <p><b>WWTP Poti 01 LOT3</b></p> <ul style="list-style-type: none"><li>• Deep pit without barrier and warning sign</li><li>• Rebar without capping</li></ul> <p><i>Deep pit without barrier and warning sign</i></p>

All these conditions have to be remedied within 10 days by the prime Contractor: **CNI23**.

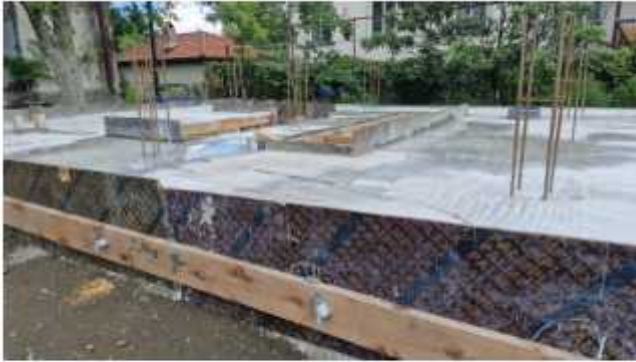
<p><i>Rebar without capping</i></p>

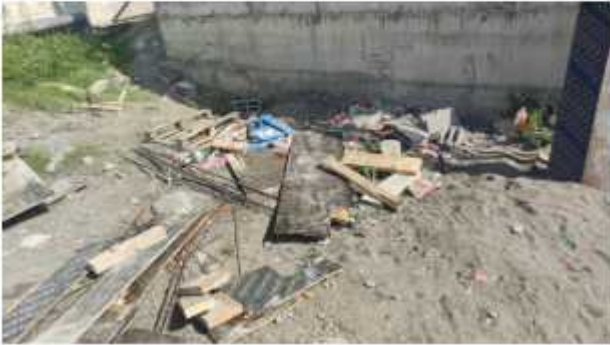
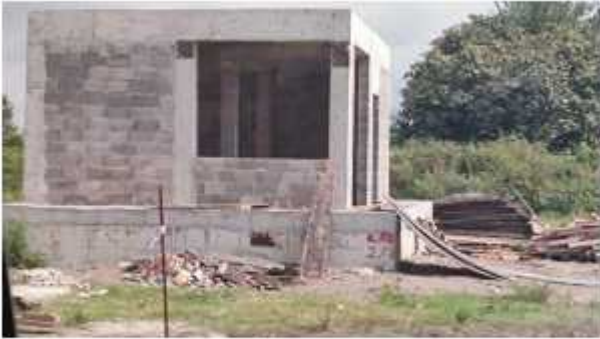
<b><u>NON-COMPLIANCE IN POTI 01</u></b>	
<b>WWTP Poti 01 LOT3</b>	
<ul style="list-style-type: none"><li>• Unacceptable housekeeping</li><li>• Generator without drip tray</li></ul>	
<b><i>Unacceptable housekeeping</i></b>

All these conditions have to be remedied within 10 days by the prime Contractor **CNI23**

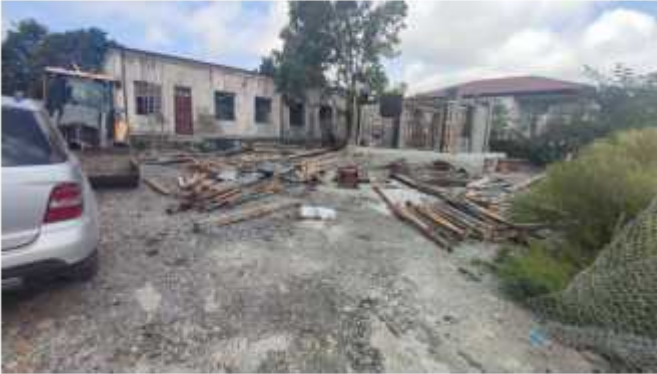
**Generator without drip tray**

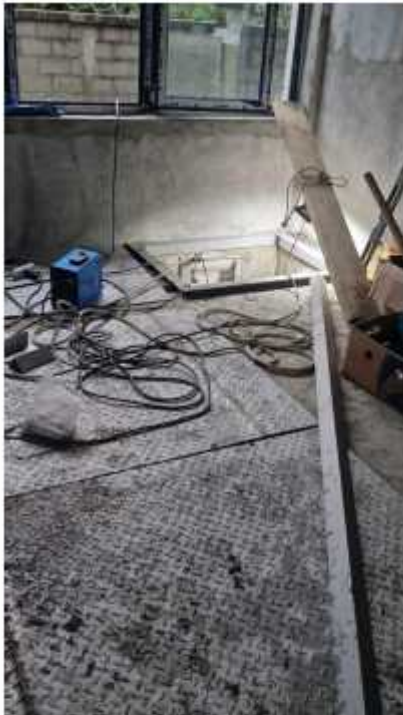
***Unsafe wiring***

**All these conditions have to be remedied within 10 days by the prime Contractor CNI23**

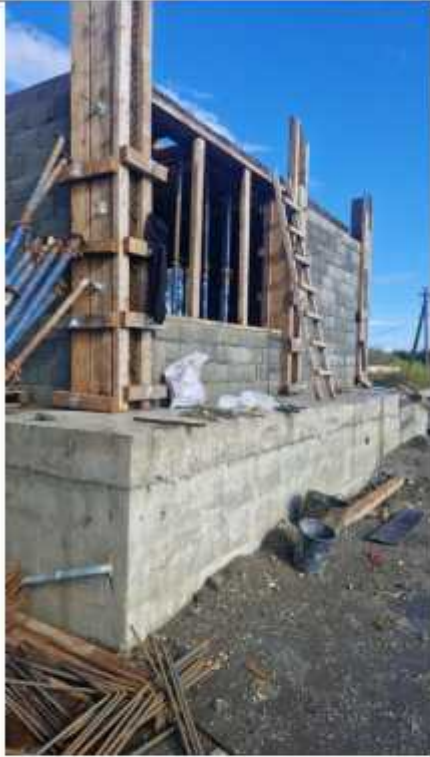
***Unsafe ladder***

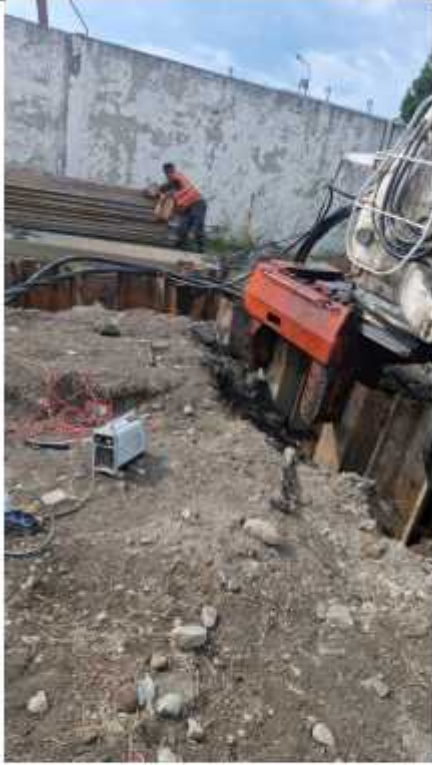
***Worker without helmet***

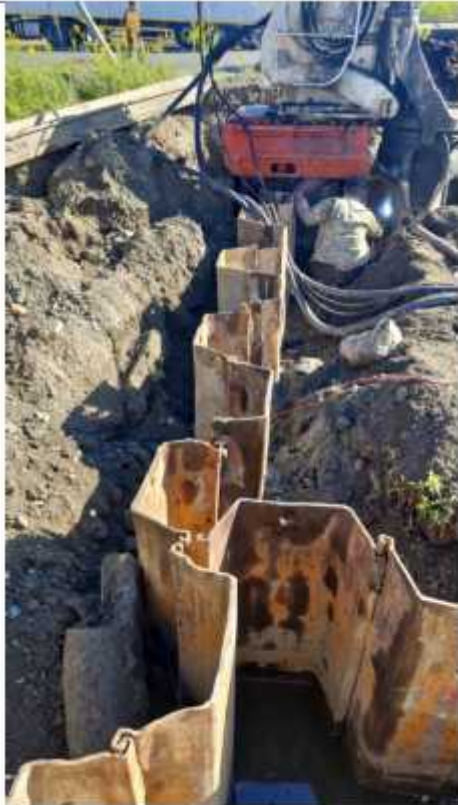
*Worker without PPE in the trench*

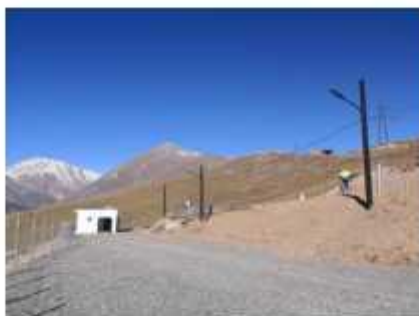
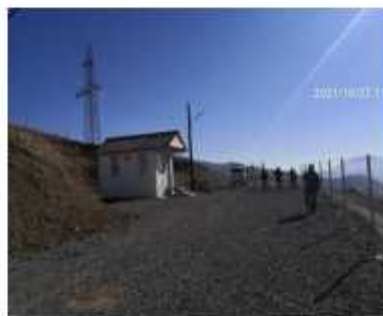
**Figures 2 and 3: Reservoir**

25. Reservoir and water wells were fenced and it was impossible for strangers as well as domestic animals to enter the site (see **Figure 2,3,4,5**).

26. The territories were restored in a timely manner; the removed topsoil was used for the rehabilitation works. The local roads of all objects are improved.
27. Soil piles with already planted grass was laid on the territory of the reservoir and PS. Small sections of the ground access roads to the facilities were also restored.
28. Both, the hazardous and household waste were totally disposed from the project zone. Besides, the construction techniques and construction materials were removed as well, and lighting poles were installed all over the area.

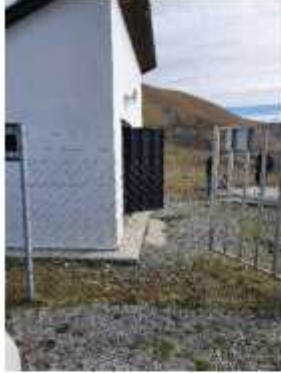
<p>3 <b>Observation 1:</b> The area around the well fields inside the fence was contaminated with animal fecal matter</p>	<p>The area of the well fields must be cleaned promptly, the gate should be closed to prevent accidental entry of people and animals into the well field area until the end of December 2024, Photo N1</p>

<p>UWSCG</p>	<p>Improved, December 2024</p>
